Mechanical Response of EN24T and EN36 Steels Subjected to Corrosion

Abstract— The purpose of this investigation was to examine the effect of corrosion on mechanical behavior of structural steels. Natural sea water was utilized to induce corrosion for the durations of 250, 500, 750, and 1000 hours. Two types of structural steels were considered: EN24T steel and EN36 steel. In order to characterize the behavior of steels under corrosion, tensile and hardness tests were conducted and their associated parameters were measured and compared with non-corroded samples. To analyze the effect of corrosion on the surface, microstructure analysis was carried out using scanning electron microscopy. The microstructure results reveal that, as the immersion time intervals increase nucleation of pits and exfoliation of surface layers is observed. Tensile test results and the associated parameters show a decreasing trend with increase in exposure durations in natural sea water. Finally, the comparative study signifies that EN24T steel shows a better resistance to natural sea water corrosion when compared with EN36 steel.

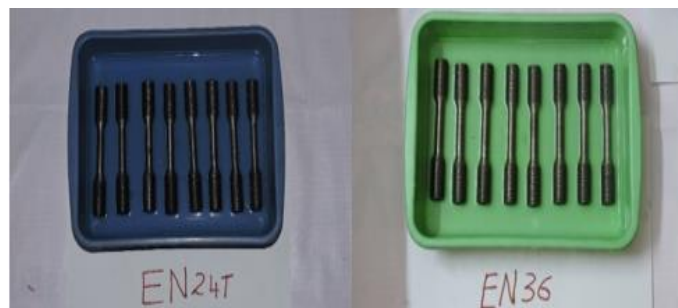
Figure 2. Test specimens immersed in sea water

Naturally manifested corrosion was permitted to occur by immersing the tensile and hardness test specimens in sea water under fully submerged conditions as shown in Fig. 2. Prior to immersion, the test specimens were polished using sandpaper and rinsed with distilled water. The specimens were immersed in sea water at room temperature for different durations of 250, 500, 750 and 1000 hours. The sea water in the trays was continually replaced at a course of two days to sustain the pH and allow adequate oxidation to the specimens to imitate the real field operating conditions. The sea water was taken from seashore at Mangaluru area in Karnataka, India.

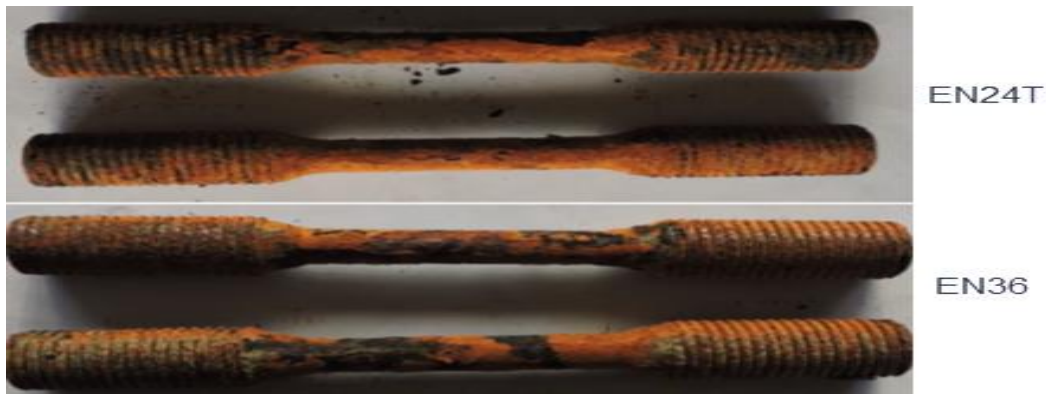
Fig. 3 shows the surface of corroded specimens immersed for 1000 hours in sea water. Clear formation of inhomogeneous black and reddish patches on both materials can be observed. The increase in immersion duration leads to excessive formation of pits and exfoliation of surface layers resulting in extensive material loss [8-10].

Figure 3. Test specimens after 1000 hours of exposure

Young's modulus decreases with exposure time for both the materials. At 1000 hours EN24T has 81.5% while EN36 has 74.3% retention of young's modulus. (Fig 8(a)). The decrease in young's modulus attributes to reduction of material stiffness which is caused by excessive material loss which can be clearly observed in Fig. 3.

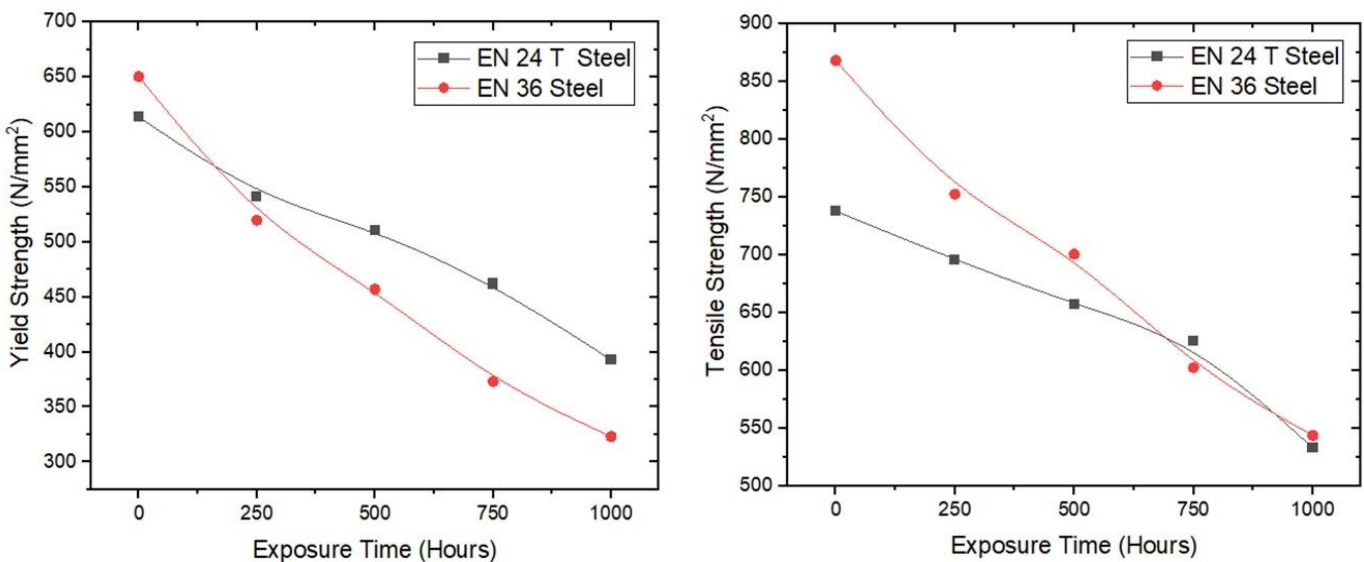
Figure 7. Variation of (a) Yield Strength and (b) Tensile Strength for EN24T and EN36 Steels with exposure time

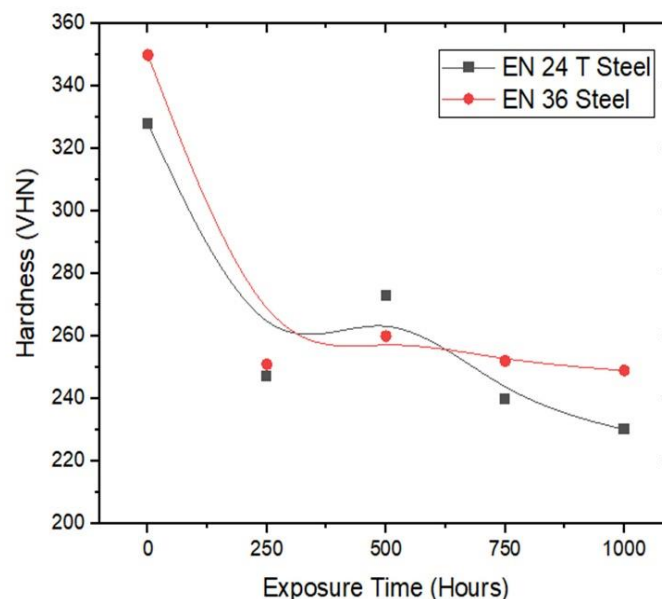
Vickers's hardness test was conducted on EN24T and EN36 steels to analyze the effect of corrosion. The variation in Vickers's Hardness Number (VHN) of EN36 and EN24T steels exposed to sea water corrosion is shown in Fig.10.

Figure 10. Variation of Vickers's Hardness Number for EN24T and EN36 Steels with exposure time

Hardness of both the materials decreases extensively at 250 hours of exposure due to surface degradation. Further, an increase in hardness is observed at 500 hours of exposure. This might be due to embrittlement of

the surface. At 1000 hours of exposure a 24.9% reduction in hardness is observed for EN24T and 28.9% reduction is observed for EN36. The reduction in hardness correlates with the investigation of surface study showing increasing in pit formation and exfoliation at 1000 hours for EN36 as compared to EN24T steel (Fig. 5).
